**National Highway  
Traffic Safety  
Administration**

Case Vehicle (A): 1999 Pontiac  
 Type: Grand Am, 2-door coupe  
 Driver: 28-year-old male  
 CDC: 12-FREN-5, 12-LDES-2

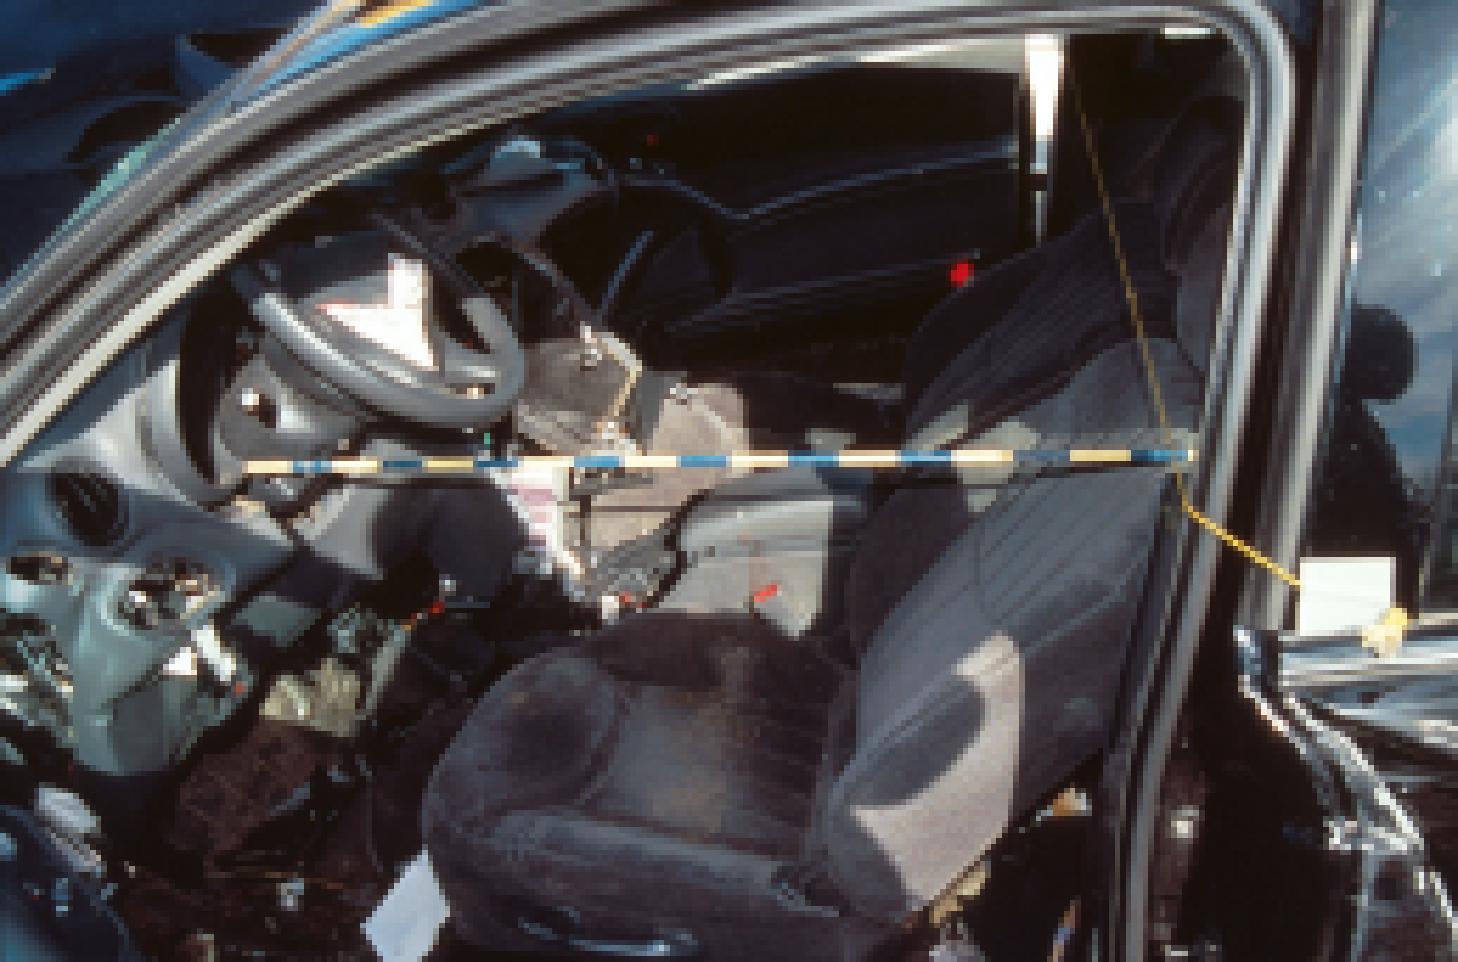
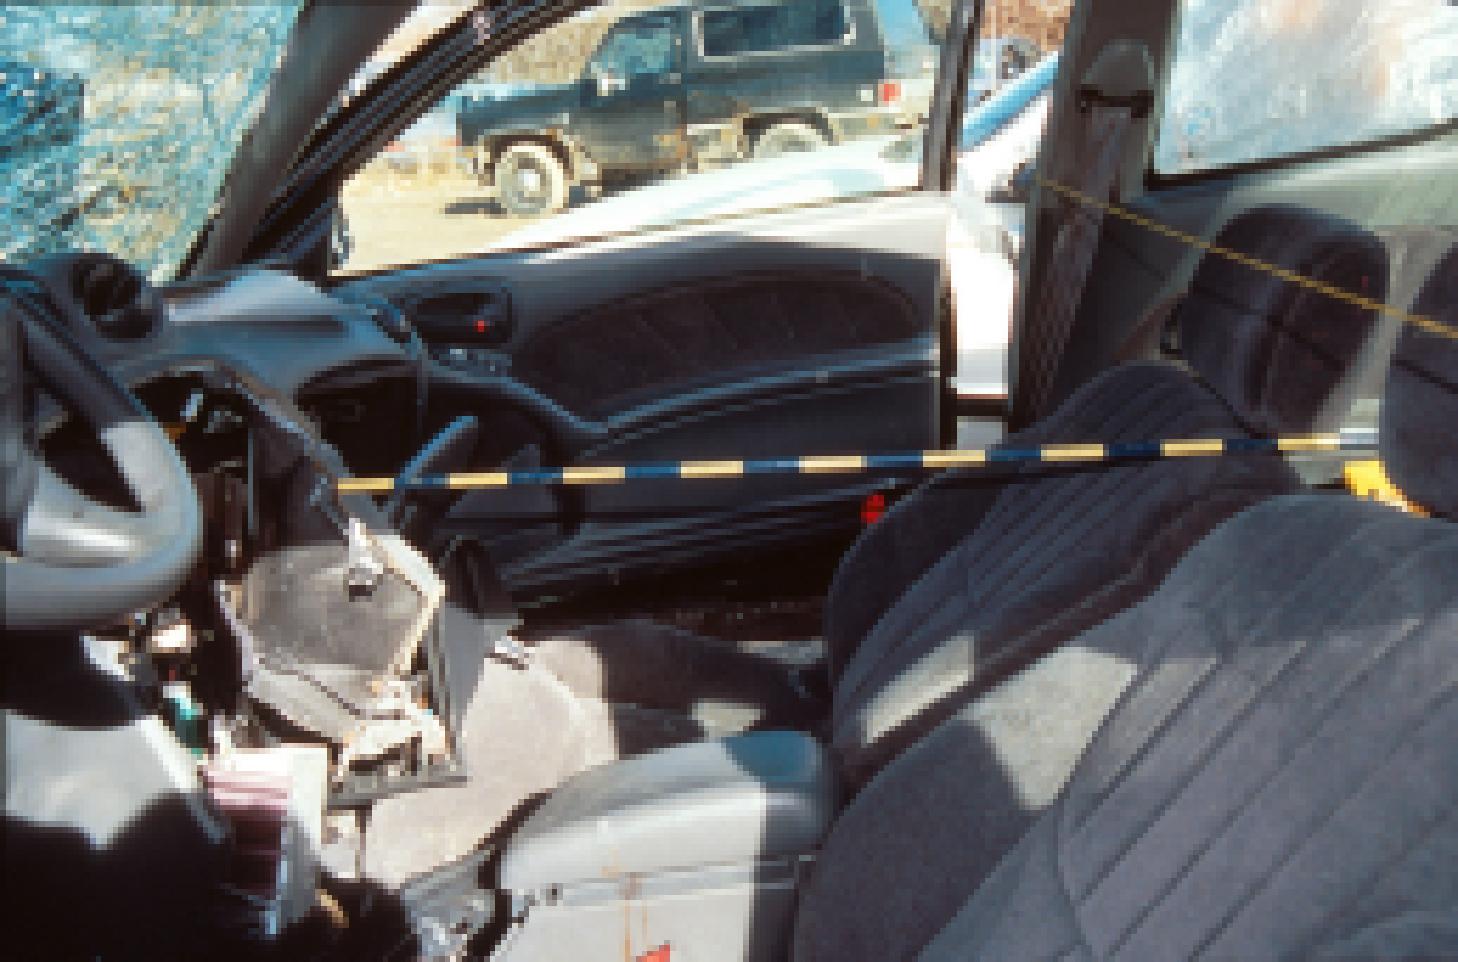
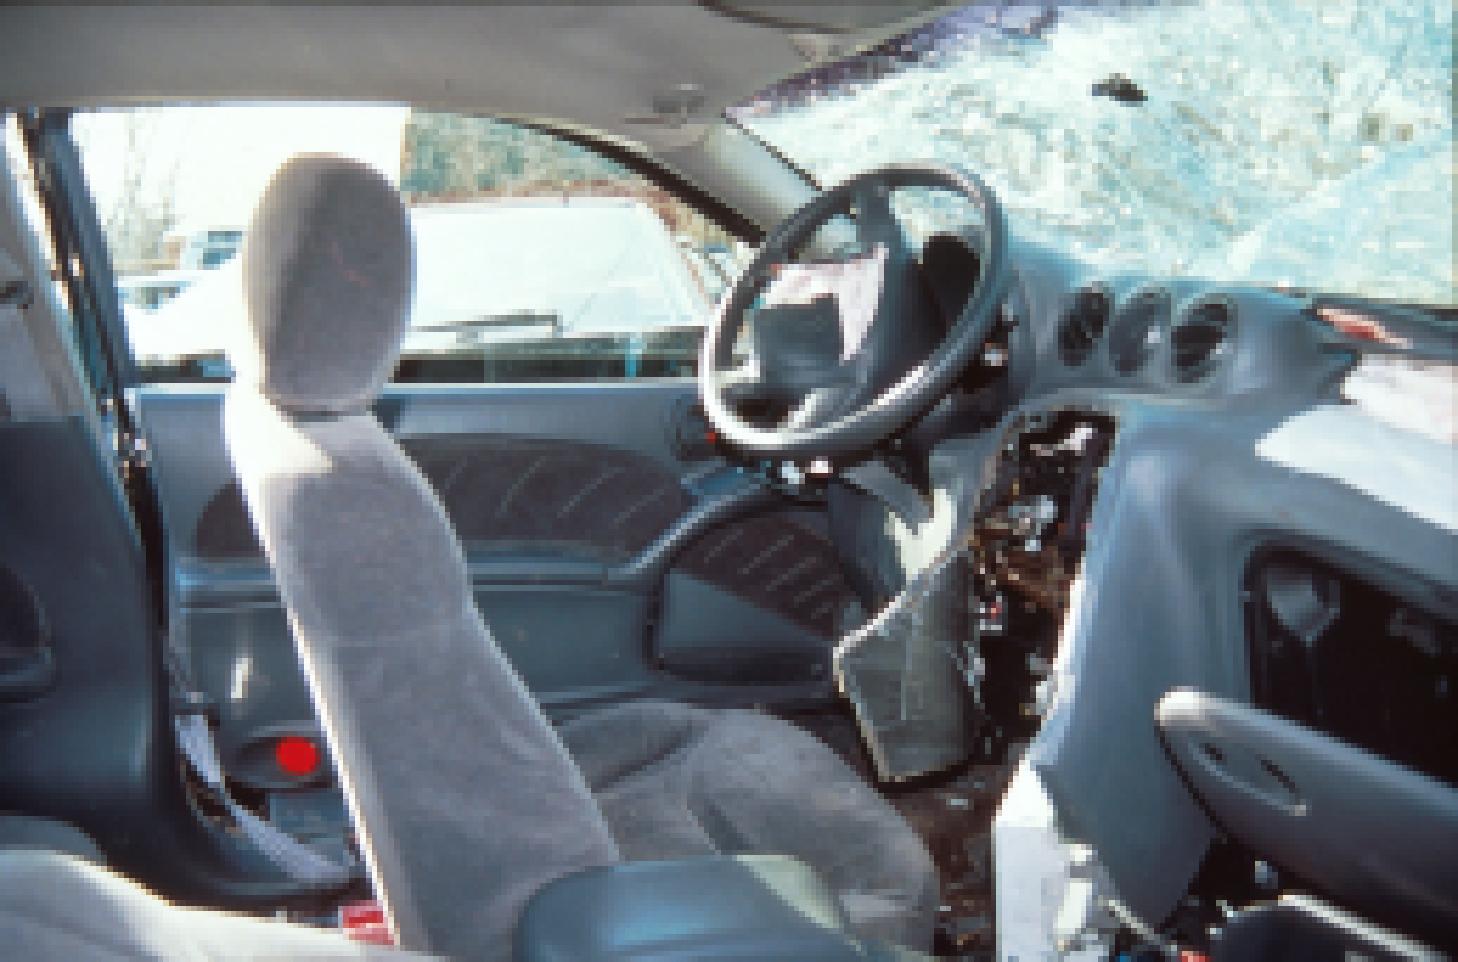
(Slides 13, 14, 15, 16, 17) This vehicle was equipped with both steering-wheel and passenger frontal-impact airbags, which deployed during the frontal impact. No damage was noted to the airbag skins or (slides 18, 19, 20, 21) to the module doors/flaps. (Slide 22) The steering-wheel rim was not deformed and there was no deformation of the steering-wheel spokes. The steering column was rotated up and to the right. (Slides 23, 24, 25) The following intrusions were noted and measured.

Location	Component	Distance (cm)	Direction
left front	toepan	35	to rear
left front	instrument panel	10	to rear
left front	door	14	to right
left front	steering column	3	to rear
center front	instrument panel	24	to rear
right front	instrument panel	21	to rear
right front	toepan	54	to rear

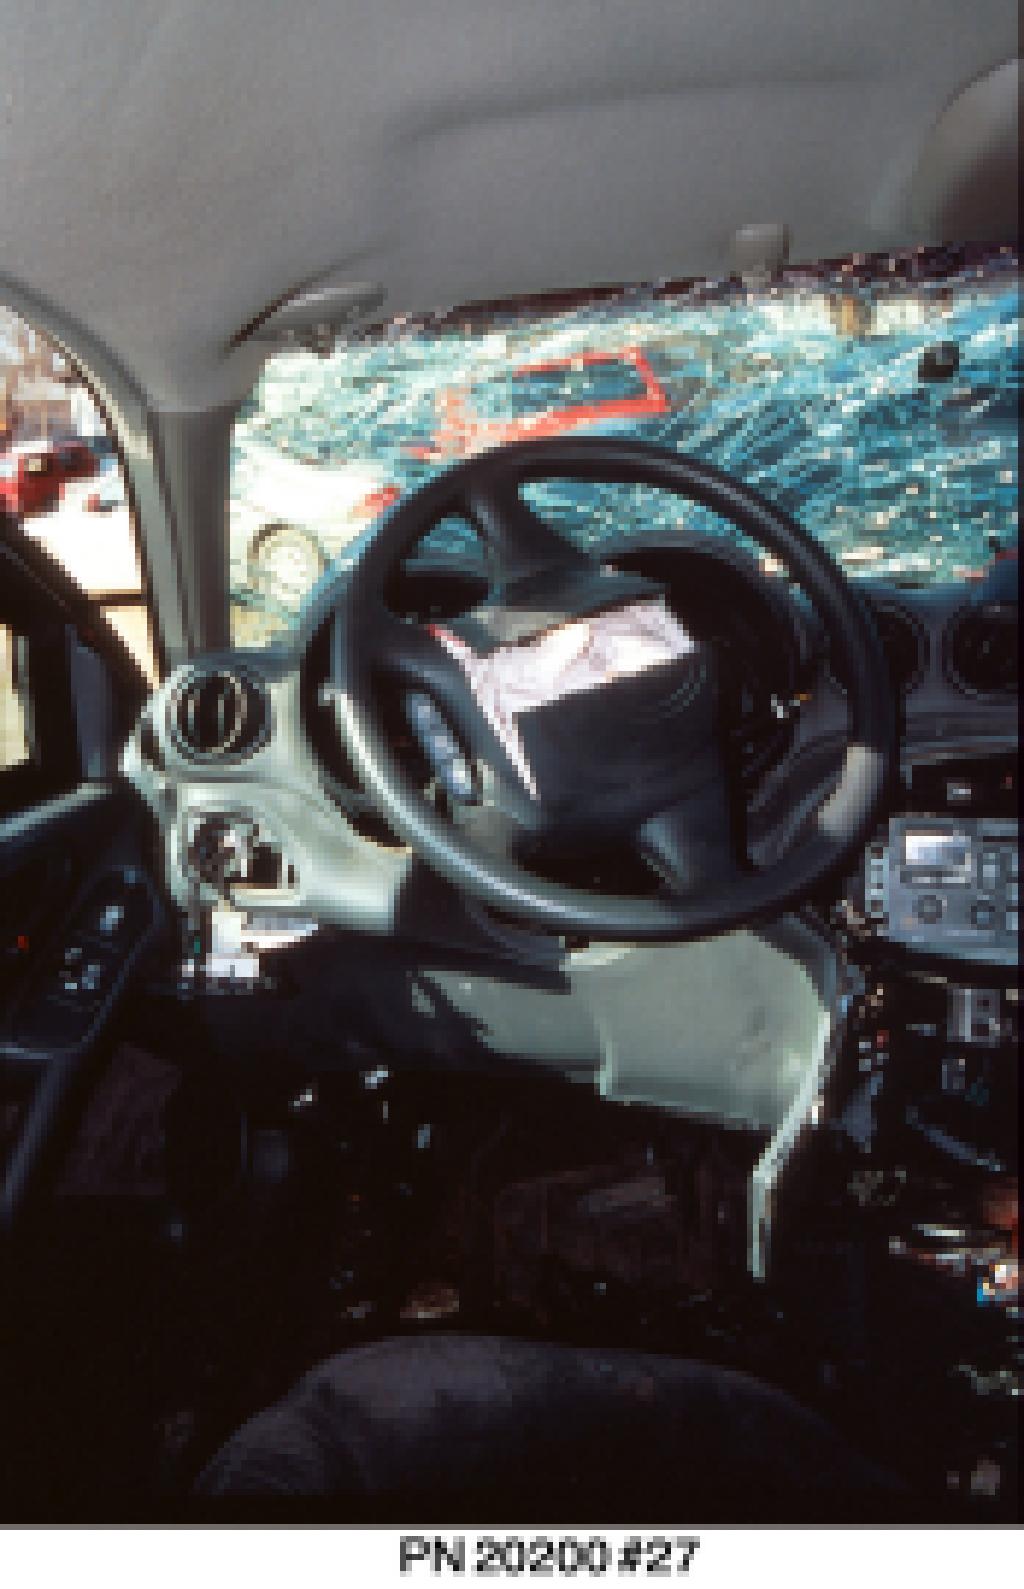
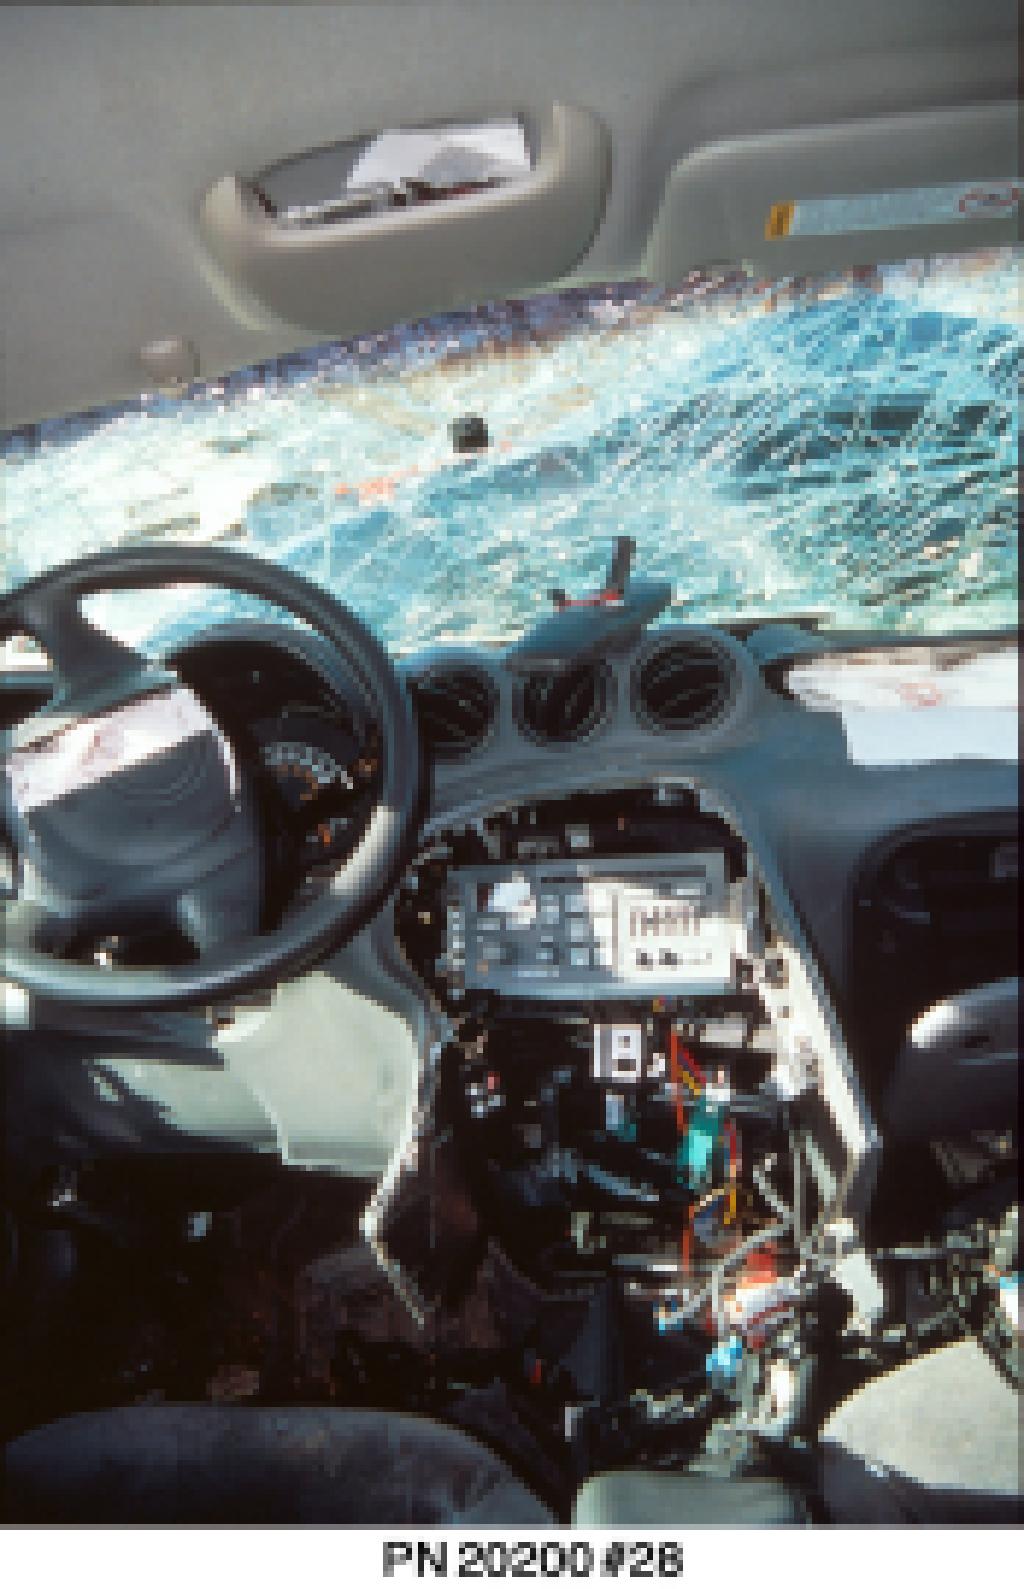
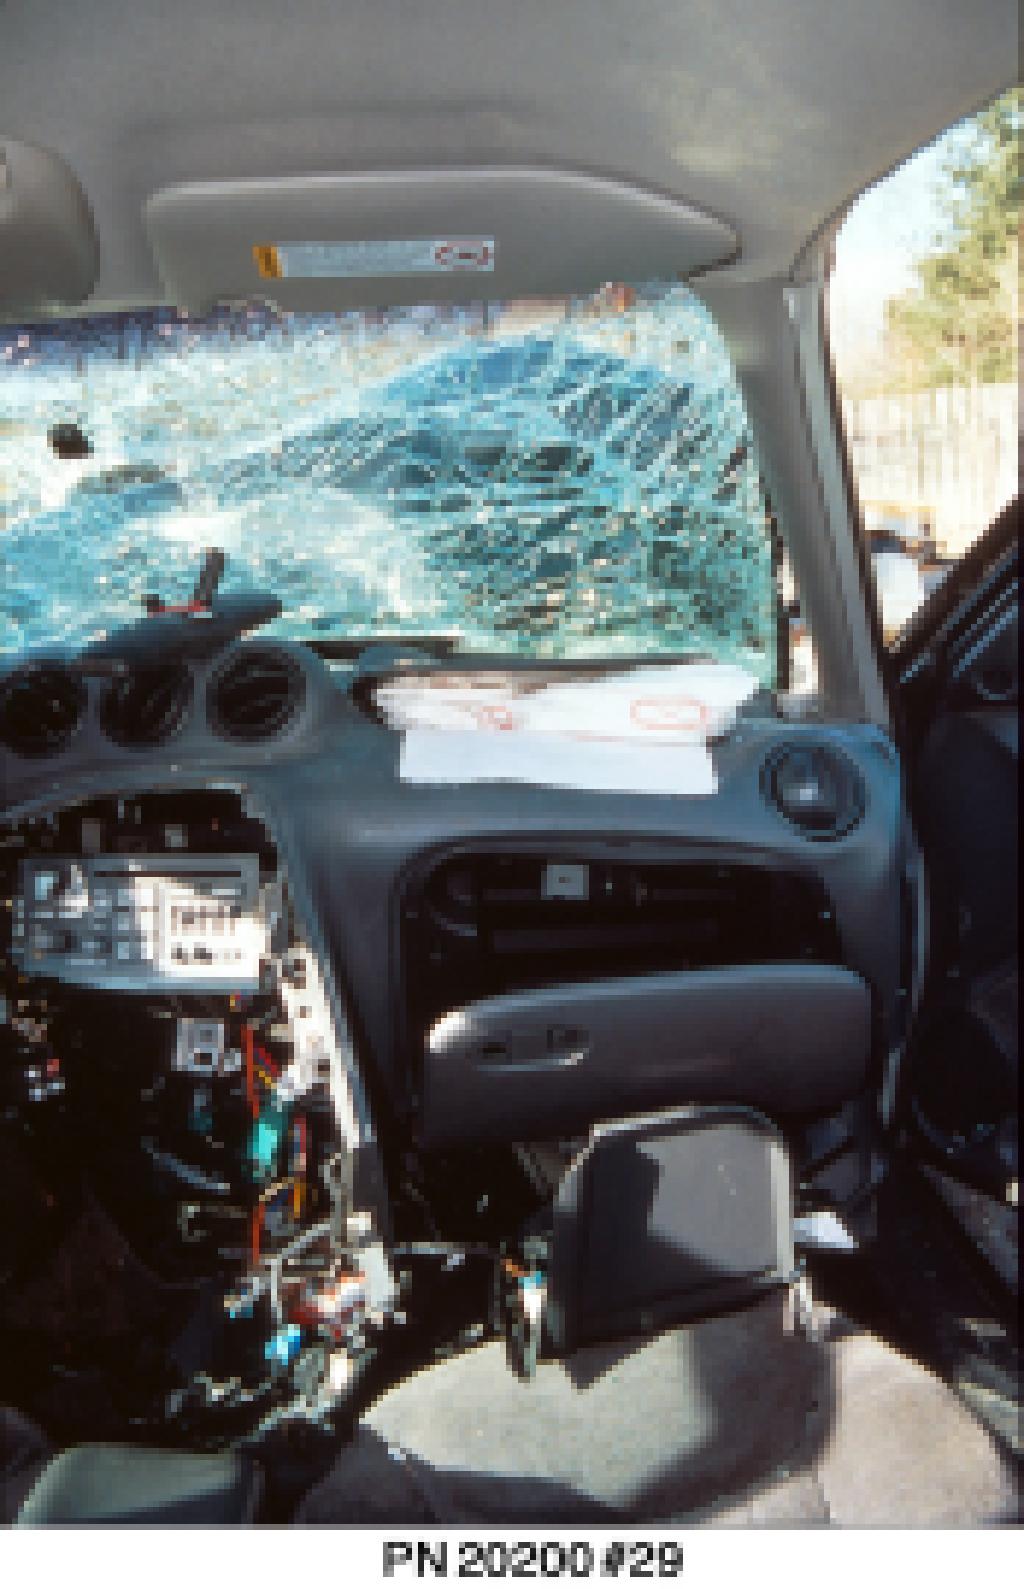
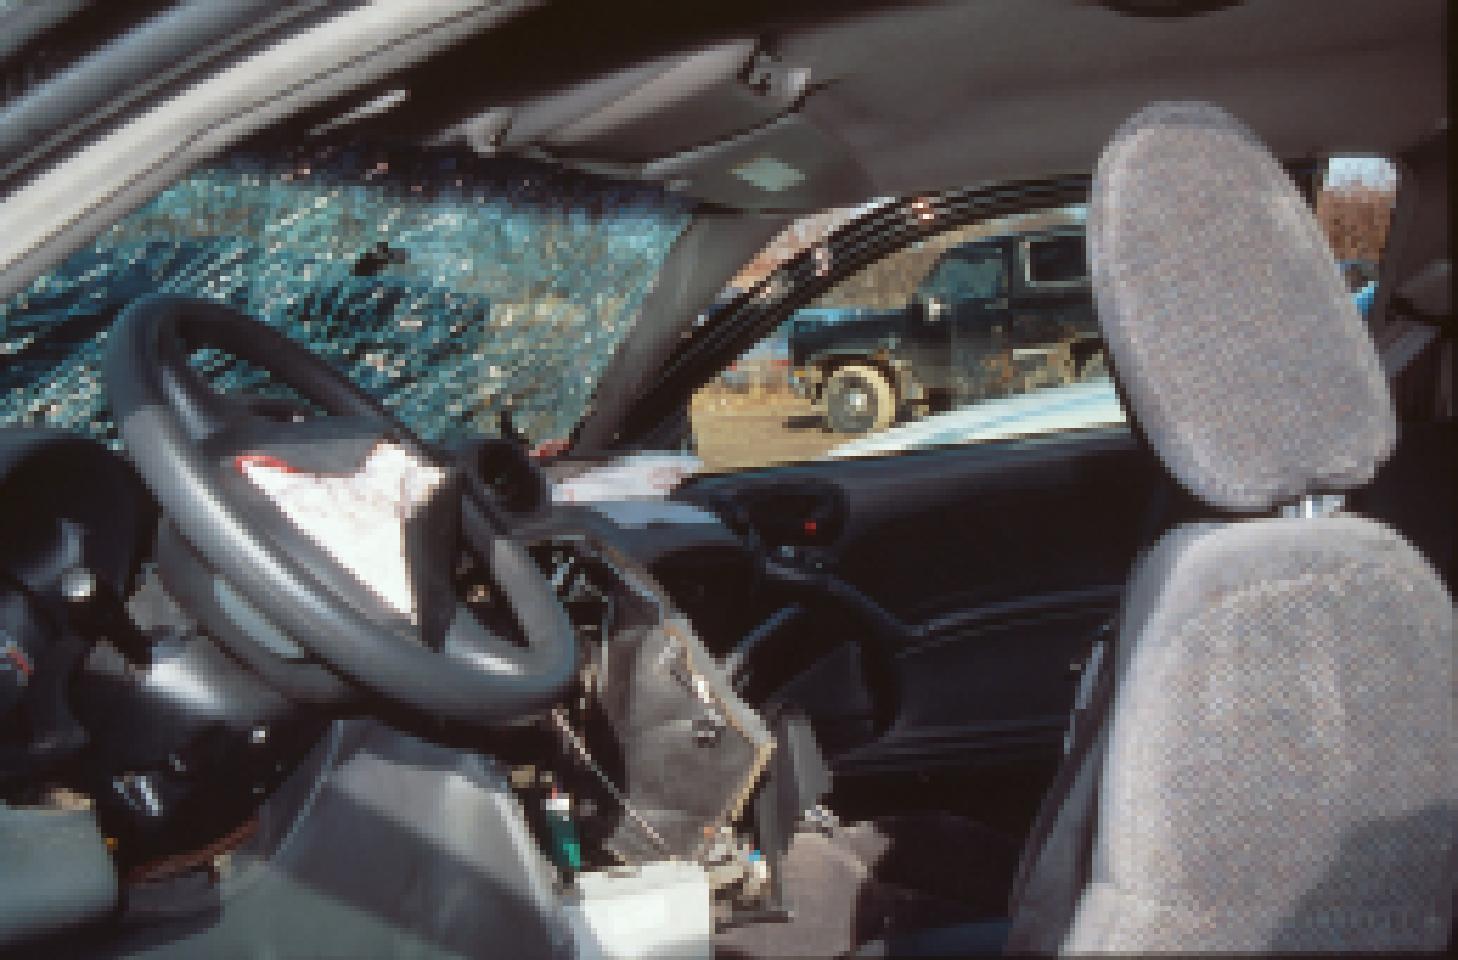
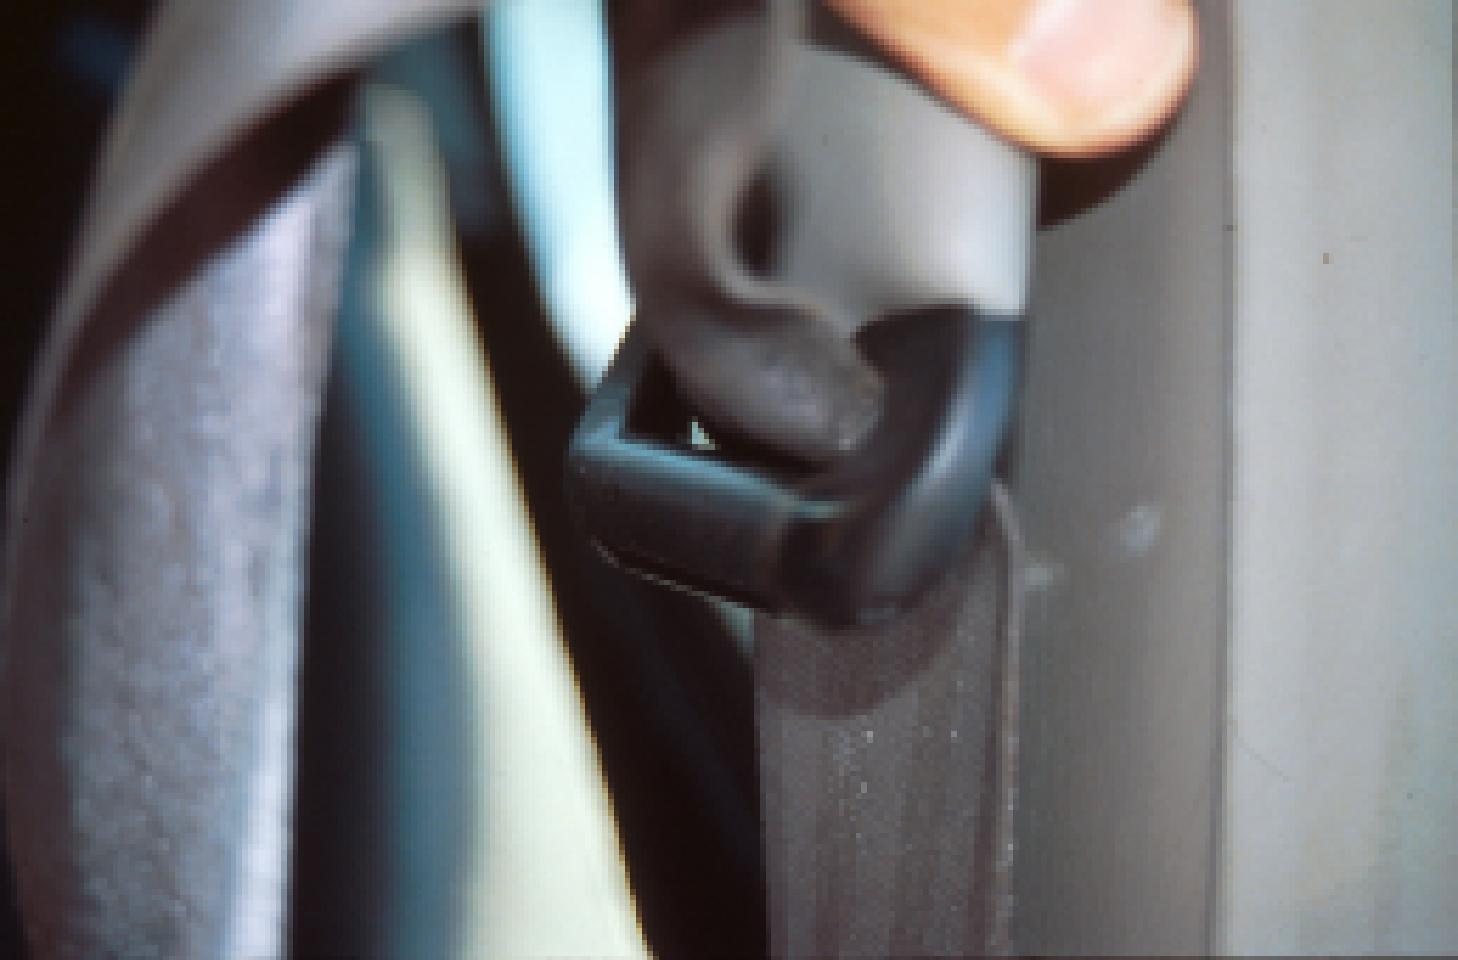
(Slides 26, 27, 28, 29, 30) The right side of the roof structure, the right side of the windshield header, and the right upper and lower A-pillar were damaged due to buckling of the vehicle body. The upper, mid and lower instrument panels, the upper and mid climate control vents, the radio, the ash tray, the parking brake lever, the glove box door, and the foot controls were damaged due to intrusion. The rearview mirror, the vertical console, the climate control knobs, the center console, and the transmission selector lever were damaged from driver contact. The left-front seat was found in the full rear position.

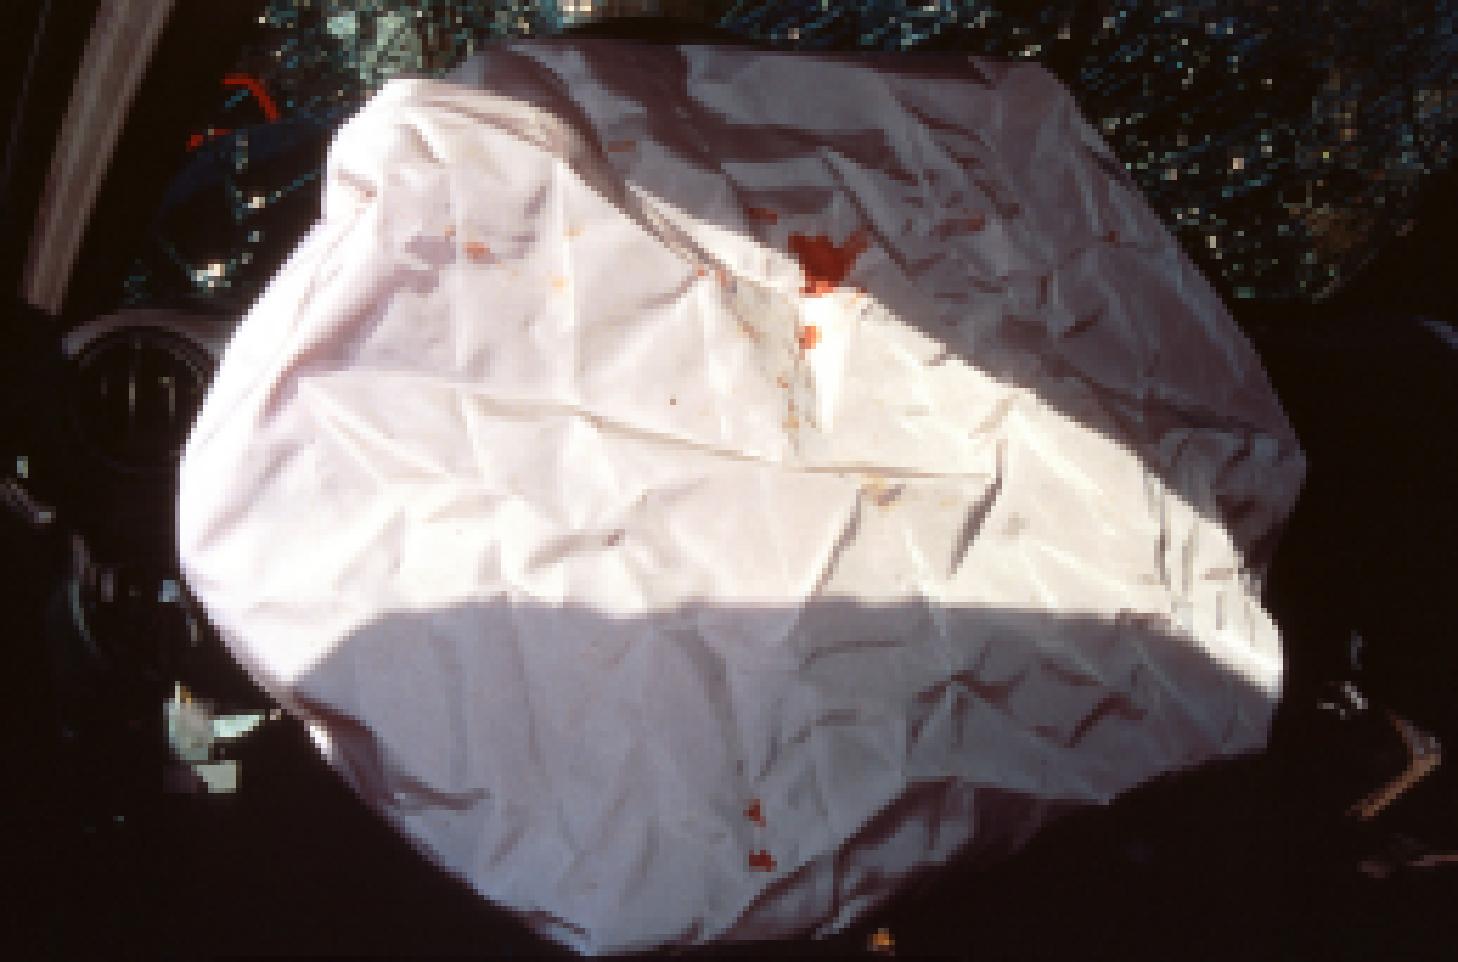
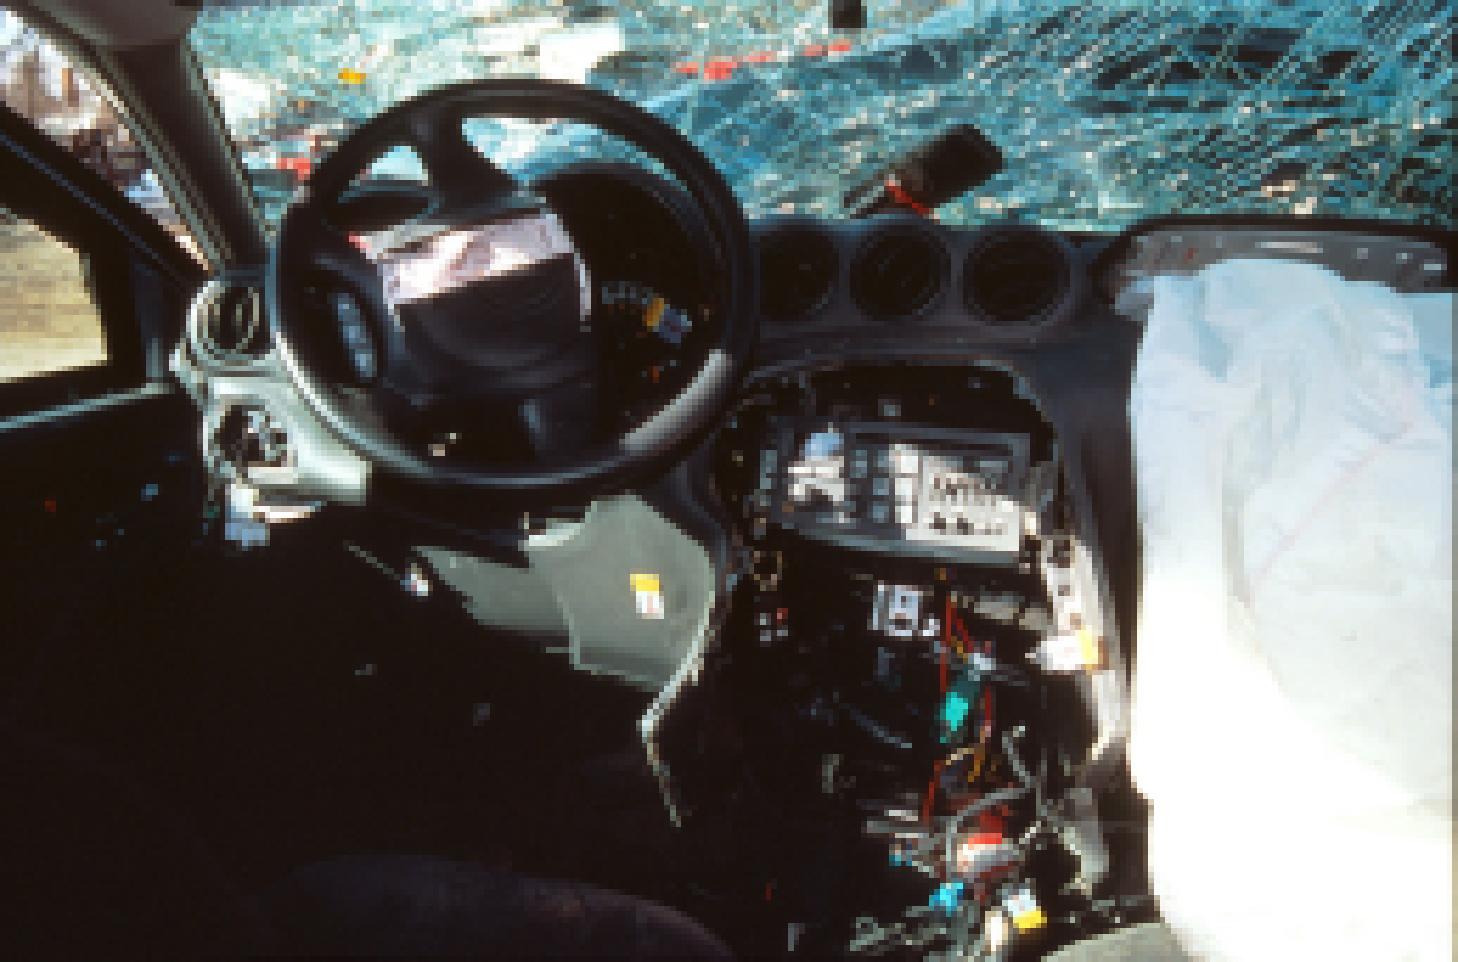
The 6-ft, 0-in, 230-lb, 28-year-old male driver (slides 31, 32) was not wearing the available three-point belt, and the steering-wheel airbag deployed. On impact, he moved forward and to

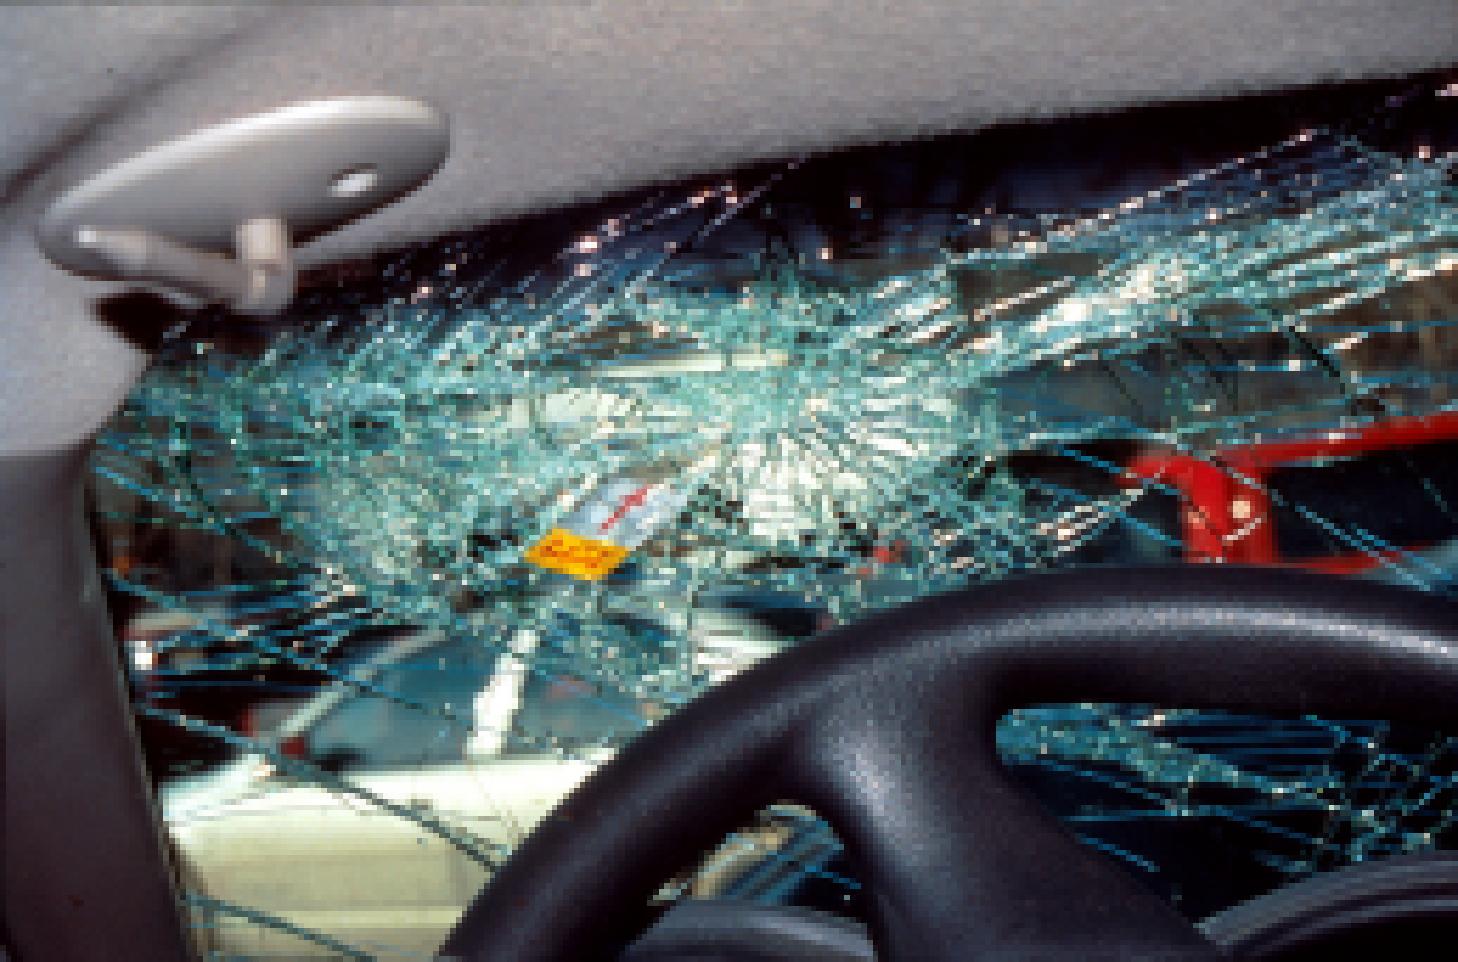
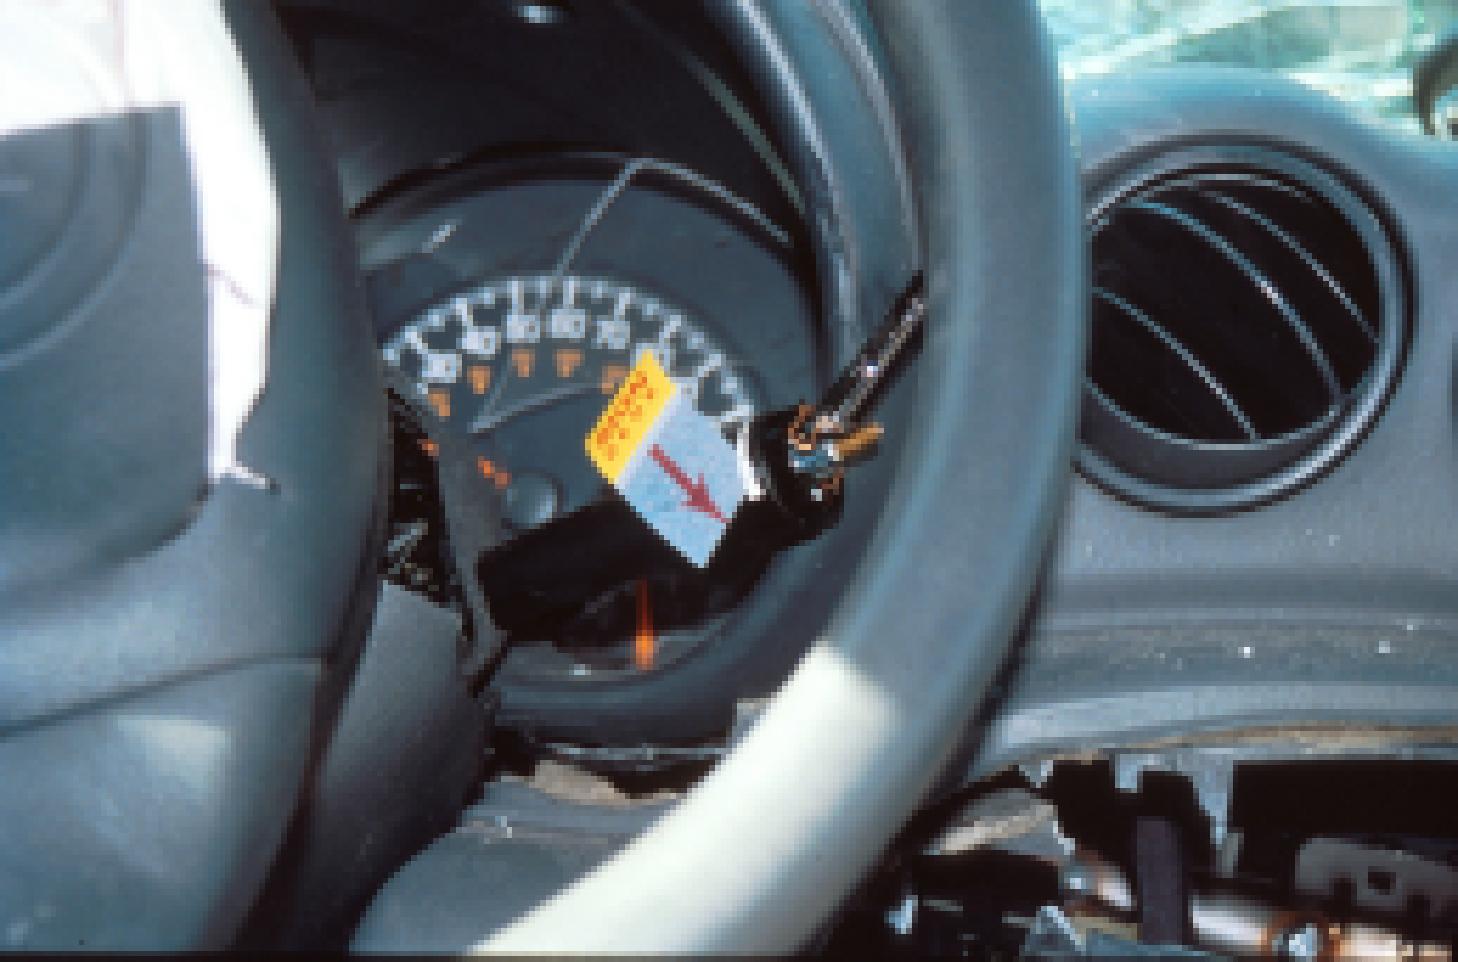
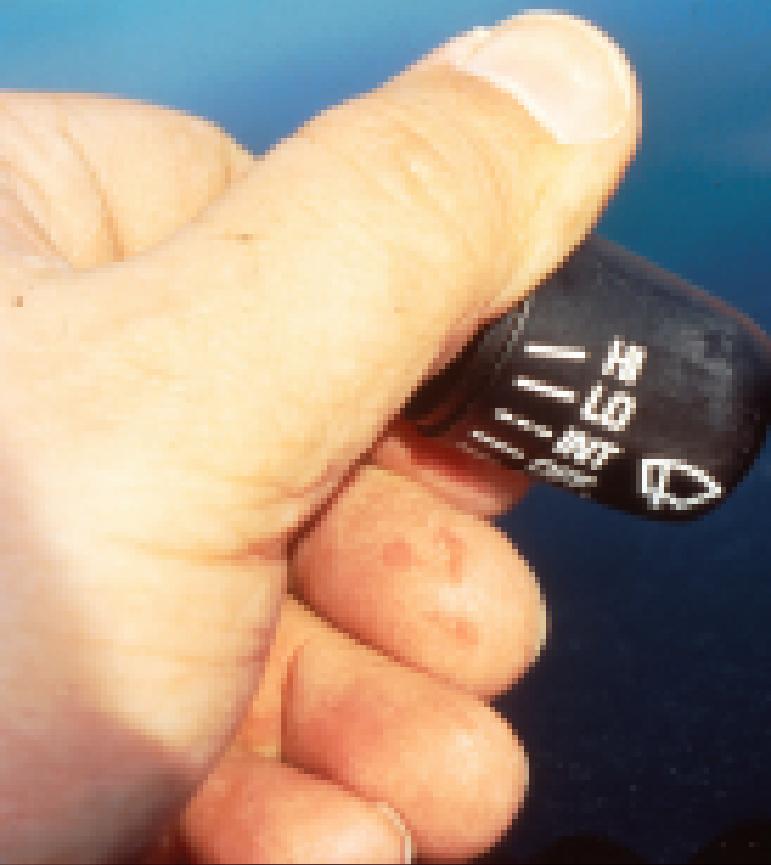
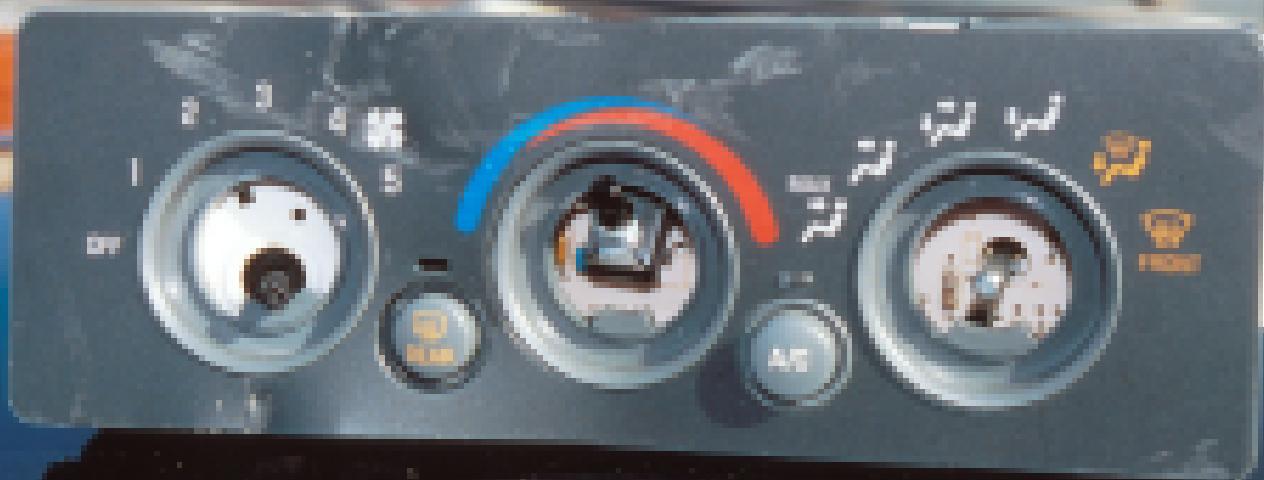
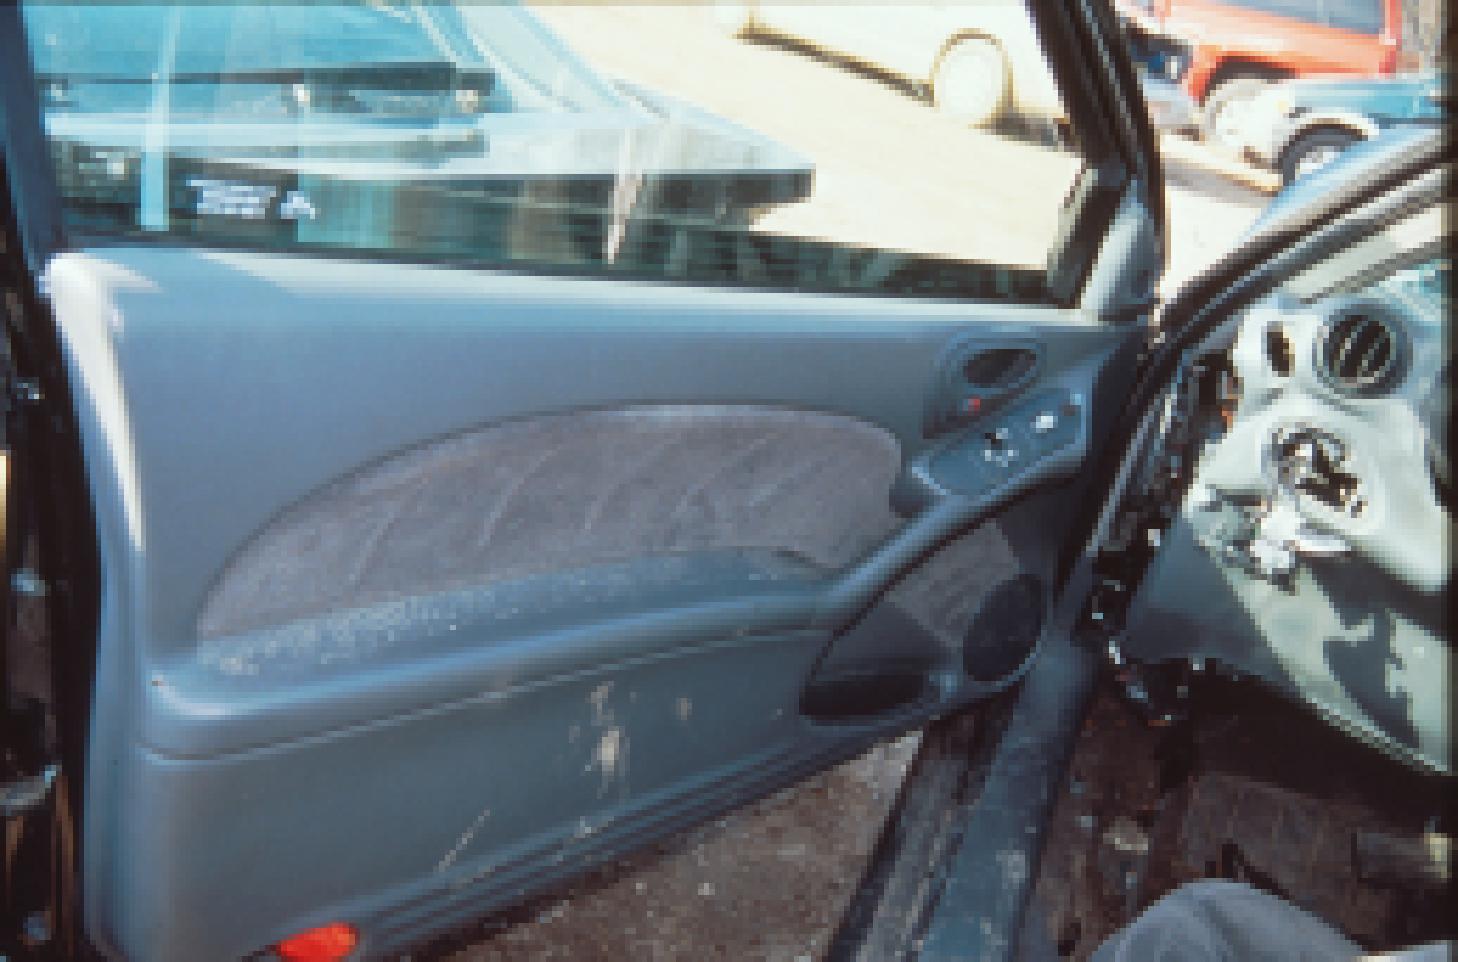
the right, skipped off the airbag, and (slides 33, 34, 35, 36, 37) contacted the vertical console with his torso and right arm. He sustained a fracture and a contusion to the left thumb, probably from contact with the steering-wheel rim, but possibly from contact with the windshield. He sustained an abrasion to the right side of his chest, probably from contact with the airbag, but possibly from contact with the vertical console. He sustained a comminuted fracture of the right humeral neck with posterior humeral head subluxation, and an abrasion to the right posterior forearm, probably from contact with the vertical console. (Slide 38) He sustained a contusion to the left lateral thigh, probably from contact with the interior surface of the left door during the sideswipe. (Slides 39, 40, 41, 42) He sustained an intertrochanteric fracture of the right femur and an open transverse fracture of the mid and distal 1/3<sup>rd</sup> of the right femoral shaft due to axial loading from contact with the knee bolster. He also sustained abrasions over both tibias, probably from contact with the knee bolster. (Slide 43) The rearview mirror was found off of its mounting plate, but no injuries were reported that could be associated with it.
